CONFINED SPACE - SITE SURVEY

SITE SURVEY

12 May 2021 /					Complete
Score	100%	Failed items	0	Actions	0
Address					
Conducted on		12th May, 2021 12:30 PM BST			
Prepared by

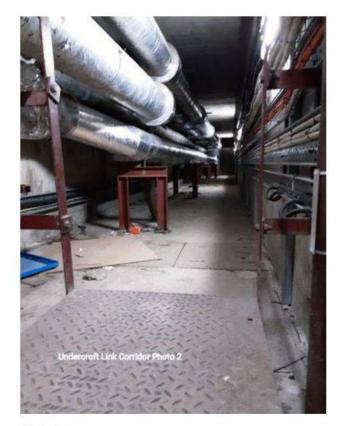
Photo 11

There is good access in to the initial space, on the left, a vertical ladder rises approx 8ft to a perpendicular brick built pipe duct. This duct progresses for approx 25m before rising again via a set of steps. The duct runs for approx 100m and is a complete dead end with no other access.

Due to the difficulty of access and the length of the duct, combined with the limited ventilation, this space should be classified as a Medium Risk Confined Space.

Oxygen flow and return pipes - copper tube running the length of the duct, possible source of oxygen enrichment of the atmosphere - an audible leak could be heard leaking from a valve in this space

Signage denoting "No Entry - Confined Space - Authorised/trained Personnel only" or similar message to be installed at entrance to confined space.

Recommend use of atmospheric monitoring devices to alert any entrants to changes in the atmosphere.

Recommend use of escape breathing apparatus to enable self rescue in the event of an atmospheric emergency.

Recommend some basic rescue training to cover stretcher packaging and use of a sliding stretcher that can also be used to lower a casualty from the top of the ladder down to the ground.

Installation of a suitable high anchor point to enable the lowering of the stretcher.

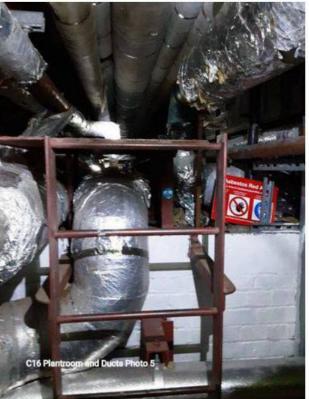
Photo 16

The C16 Plantroom is recommended to be designated as a restricted space as opposed to a confined space. The area that is located down the stairs and through the doors is a series of brick built pipework/cable ducts. It is recommended that the ducts are classified as a medium risk confined space due to the limited ventilation and tight access and egress. The main duct has reasonable access and egress, but the duct immediately to both the left and right have very limited restricted access/egress. It would be extremely difficult to extricate a casualty.

Potential for asbestos

Tight access and egress from some of the ducts

Signage denoting "No Entry - Confined Space - Authorised/trained Personnel only" or similar message to be installed at entrance to confined space.

Recommend checking asbestos register to confirm absence of asbestos.

Recommend use of atmospheric monitoring devices to alert any entrants to changes in the atmosphere.

Recommend use of escape breathing apparatus to enable self rescue in the event of an atmospheric emergency.

Recommend some basic rescue training to cover stretcher packaging and use of a sliding stretcher.

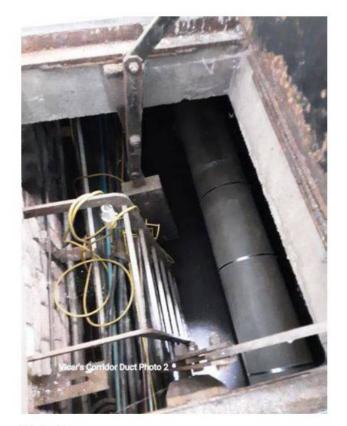
Photo 21

This service duct is roughly 500m long and runs under the full length of the Vicar's corridor. It is larger at the Porters Lodge end and considerably smaller at Sorby end.

There are access hatches into the duct every 15-20m, but some hatches may not have been lifted for upwards of 30 years. There is ground water intrusion on occasion and also an open grey water drain that runs in the duct.

The duct houses an 9", 6 bar water main that would provide a considerable threat to life if it were to rupture, filling the small space very quickly. There is also a natural gas line running the length of the duct.

Ventilation in the space is naturally very limited and there is a real possibility of rat infestation.

Signage denoting "No Entry - Confined Space - Authorised/trained Personnel only" or similar message to be installed at entrance to confined space.

Consider refurbishing and identifying escape hatches, both inside and out.

Consider making some hatches light weight so as to make it easier to open from inside the space.

Consider fitting lighting to the space.

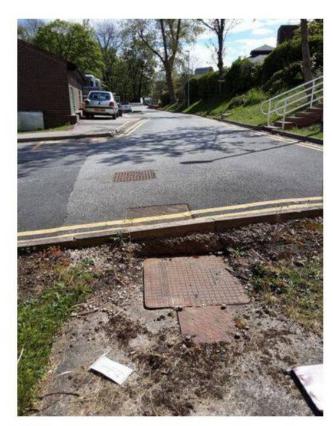
Photo 27

Underground service duct carrying heating pipes, access is gained via a series of manholes. The duct links up with another duct that runs between "Brierley and the boiler house".

There is evidence of the ingress of groundwater and the very real possibility of the presence of rats and therefore leptospirosis. There are ventilated lids on some of the access hatches although this cannot guarantee a safe atmosphere.

Signage denoting "No Entry - Confined Space - Authorised/trained Personnel only" or similar message to be installed at entrance to confined space.

Ensure all contractors are suitably qualified and have the correct equipment to carry out the task without compromising safety.

Consider asking them to demonstrate their rescue plans prior to work commencing.

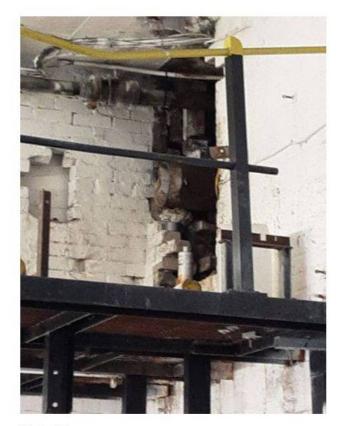
Photo 35

Multi level, brick built pipe ducting running underground for approx 100m, there are 3 drops via cat ladders over length of the duct. The duct that runs to Spinal injuries joins this duct approx half way along the length. The Brierley end of the duct is accessed via a small brick built shed that houses a vertical cat ladder, the other end of the duct terminates in the boiler house at high level onto a steel staging that is accessed via another vertical ladder.

Limited access/egress

Limited working space within duct due to pipe work and cable runs

Ingress of ground water.

Signage denoting "No Entry - Confined Space - Authorised/trained Personnel only" or similar message to be installed at entrance to confined space.

Ensure all contractors are suitably qualified and have the correct equipment to carry out the task without compromising safety.
